THE "AGING" MECHANISM in Electron Multipliers and Operating Life.

Aaron D. Cutter (1), Kevin L. Hunter (2), Peter J. K. Paterson (3) and Richard W. Stresau (1)

Presented at the 42nd ASMS Conference on Mass Spectroscopy and Allied Topics
May 29-June 3, 1994, Chicago, Illinois

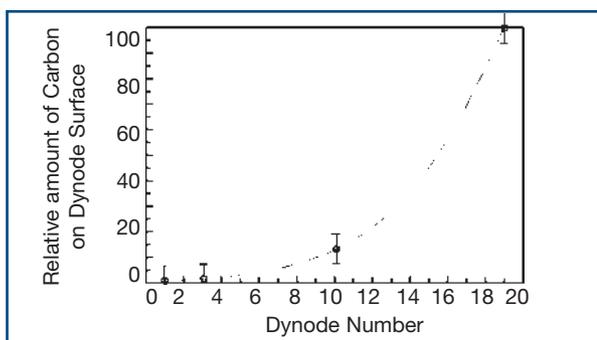
Figure 1 Relative level of carbon contamination on dynode surfaces (dynode #20: last dynode).

As would be expected, the dynodes closer to the output of the multiplier are exposed to much greater doses of secondary electrons than those dynodes closer to the input. The shape of the curve in **figure 3** is very close to that seen in **figure 1**.

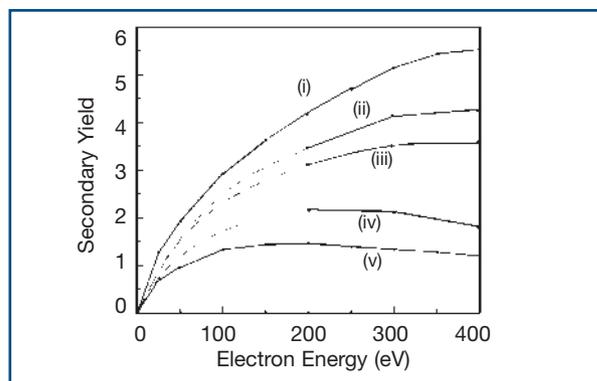
Figure 2 Secondary electron yield from (i) a new dynode surface of an *ACTIVE FILM Multiplier* and those of an aged multiplier (ii) dynode 3, (iii) dynode 10, (iv) dynode 19, and (v) the surface of a specially prepared heavily contaminated dynode covered with a very thick carbon layer (for comparison).

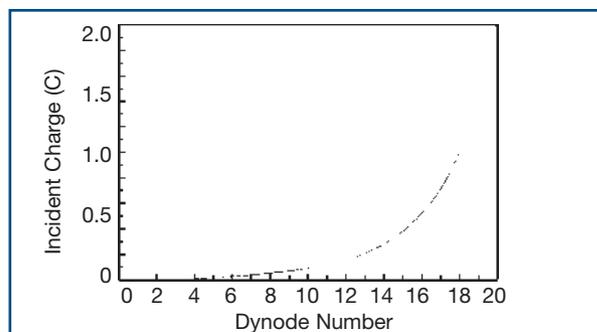
Figure 3 Theoretical calculation for the total electron dose incident on each dynode.

Using computer simulation techniques to closely model the operation of a discrete-dynode multiplier, we can estimate the total dose of electrons incident on the surface of each dynode (**figure 3**).

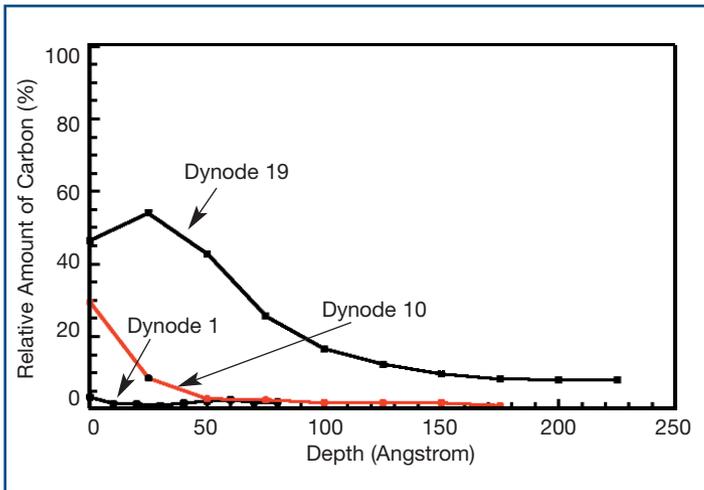
Analysis of the dynode surfaces was conducted using Auger Electron Spectroscopy (AES). The main contaminant observed on the dynode surfaces was carbon. Contaminant levels increased dramatically on the dynodes nearer to the output end of the multiplier (**figure 4**).

All the dynodes of the multiplier were exposed to the same environment for the same time interval. The only difference between the dynodes is the dose of secondary electrons they received during the accelerated aging process. This leads us to conclude that the dose per unit area of secondary electrons irradiating the dynode surface is the dominant factor governing the rate at which the dynode surface is contaminated.

Figure 4 Depth profiles, taken using Auger Electron Spectroscopy (AES), of the relative amount of carbon contamination on the dynode surfaces of a heavily used multiplier. Dynode 1 corresponds to the first dynode and dynode 19 is the near output.

- Since the process of aging is directly related to the total accumulated charge of electrons per unit area on a dynode surface, an obvious way of increasing the useful life of a multiplier is to increase the surface area of the dynodes. This spreads the electron dose out over a larger area, reducing the accumulated charge per unit area on the dynodes. This is particularly true for the dynodes in the latter third of the dynode chain where the secondary electron currents are much larger.
